ANALYSIS OF CORRECTIVE MAINTENANCE MONITOR CCA TOOL DVOR SELEX TYPE-1150A

Raihan Abrar^{1*}, Feti Fatonah², Adenia Kusuma Dayanthi³,
M. Efaldes Syahputra⁴

^{1,2,3}Politeknik Penerbangan Indonesia Curug, ⁴Politeknik Penerbangan Palembang

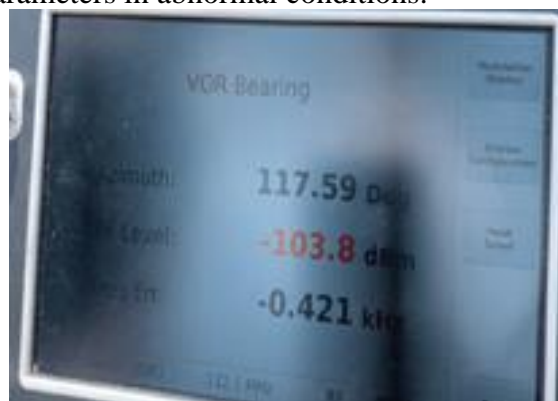
Next, the technician checked the Antenna Field Monitor, by lowering the antenna and checking the impedance value using an Avometer and getting an abnormal impedance value of 80 ohms, then the technician checked the antenna transmission cable from the field monitor using the PIR Antenna as a replacement for the Antenna Field Monitor. These procedures are based on earlier research that was carried out after the equipment damage operation and was obtained from the results assessing the antenna reception parameters in abnormal conditions.

Figure 1. Results of checking antenna transmission on PIR

Then the technician replaced the RJ-8 transmission antenna cable with a new spare, then rechecked it and obtained the results of receiving the parameters in normal conditions, then the technician replaces the Field Monitor Antenna using a new spare and raises the Antenna to check the reception value of the antenna beam using PIR. As a result of checking using PIR, it was found that the beam reception value was in good condition.

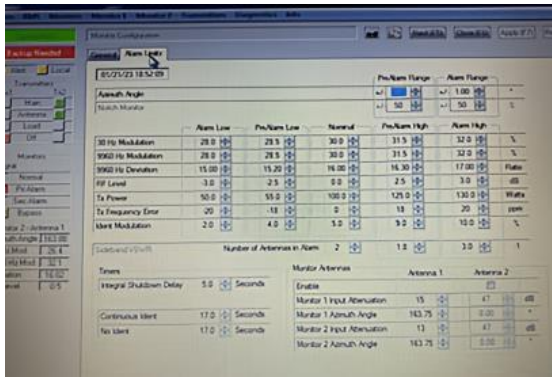
Figure 2. Load Configuration and Setting Attenuation Using PMDT

Next, the technician carries out load configuration and sets the attenuation so that the RF reception level on the monitor module is in accordance with standard parameters, it was found that the RF reception level on monitor 1 (one) did not meet the standard but on monitor 2 (two) was normal. After that, the technician checked the Splitter and tried using the Splitter with a new spare. It was found that there was no change in the RF Level value on Monitor one (1).

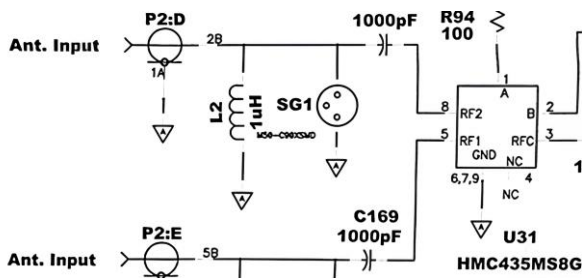
Further, the technician removes Monitor Module 1 (one) and checks several components on the Monitor module. It was found that on IC U31 with type-HMC435MS8G, there was a shortness in the number of circuits when checking using an Avometer. Then the technician removes IC U31 from the PCB board to ensure component damage. And the component is certainly damaged.

Figure 3. U31 IC wiring diagram

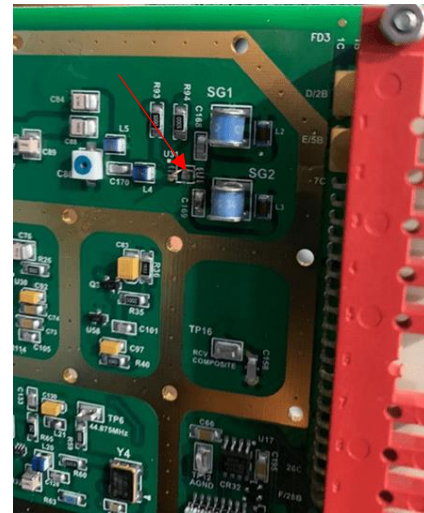
Figure 4. The Position of The IC U31 has Been Removed, Indicated by the Position of the Arrow

Then, the technician jumps pin 3 to pin 8 (without using an IC) and checks again on another circuit. Normal parameter condition in PMDT is illustrated in Figure 5.

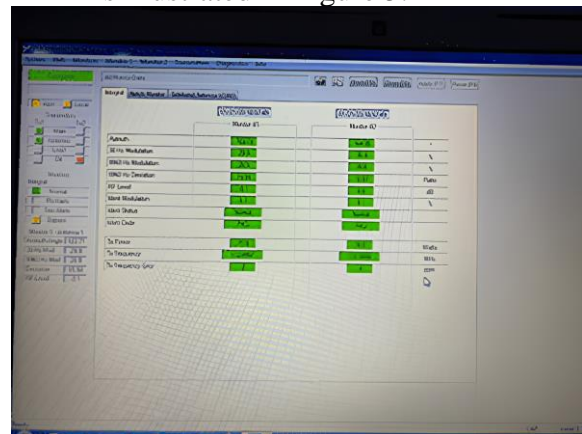
Figure 5. Normal Parameter Conditions in PMDT

Monitor module 1 is reinstalled, the RF Level is stable and the attenuation is set again. RF Level Monitor 1 (one) reading results on PMDT are in normal conditions. Currently, Monitors 1 and 2 have returned to normal.
