## MAINTENANCE ACTION ON COURSE POWER AMPLIFIER TRANSMITTER GLIDESLOPE SELEX 2110

Brahmantya Adi Atmaja<sup>1</sup>, Mochamad Faisal Yoga<sup>2\*</sup>, Sarrum Hadid  
Habib Saragih<sup>3</sup>

<sup>1,2</sup>Politeknik Penerbangan Indonesia Curug, <sup>3</sup>Perusahaan Umum Lembaga  
Penyelenggara Pelayanan Navigasi Penerbangan Indonesia

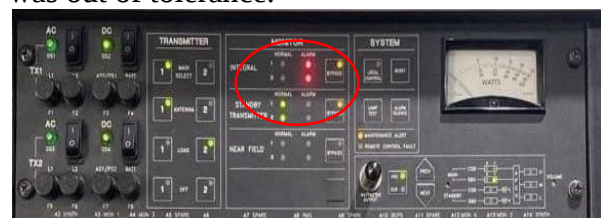
**Figure 2.** Alarm Condition on Monitor LCU

This research was conducted considering that glideslope equipment is crucial in the aircraft landing process, which impacts Runway Occupancy Time, as indicated by the study (Lim et al., 2020). Problem Analysis identify on December 27, 2022, there was a report from Approach Control Pekanbaru and Tower Pekanbaru that the glideslope signal for the aircraft was out of tolerance by 3°. Following up on this report, an analysis was conducted by directly inspecting the glideslope equipment shelter. It was found that the LCU monitor on the integral transmitter (transmitter

1) showed a Glideslope alarm, and the RF SBO Power reading on the Wattmeter was 0 watts. An inspection was also carried out using PMDT, and the reading for the width DDM was out of tolerance.

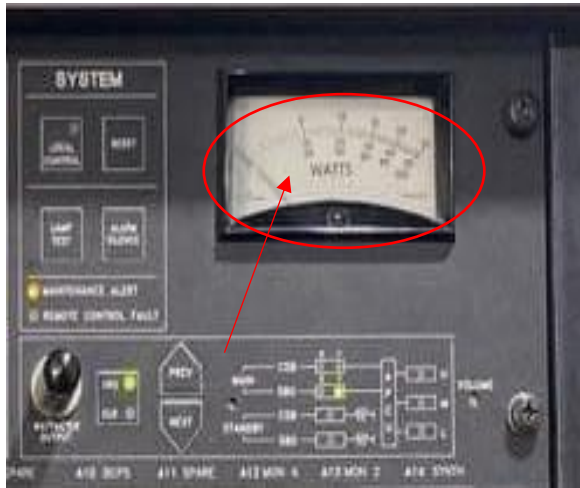
**Figure 3.** Reading of the Wattmeter on the SBO Power Parameter

The action of checking the equipment monitor and reading the power parameter on the Glideslope equipment is carried out to determine the cause of the aircraft receiving a Glideslope signal that is too high (Ariba et al., 2017). Subsequently, further checking of the transmission parameters using PMDT is conducted.

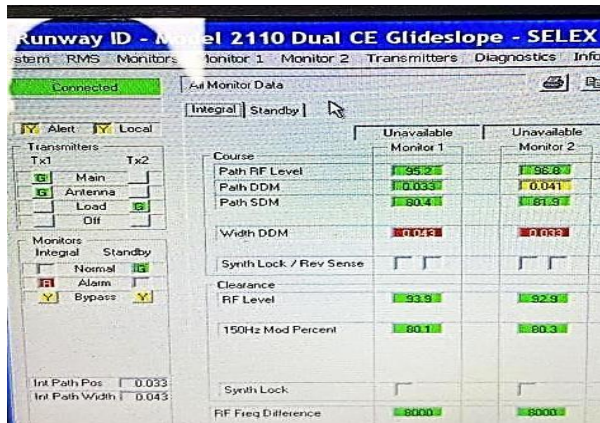
**Figure 4.** Reading of the Transmission Parameters on the PMDT

Checking the transmission using PMDT on all monitor data of the integral transmitter yielded parameter readings indicating that the width DDM was below the normal limit, triggering an alarm. Several findings were noted alarm on the LCU Integral transmitter monitor, parameter reading of RF Power SBO at 0 Watt parameter reading of the integral transmitter's transmission on PMDT showed Width DDM below the normal limit. The subsequent action taken is to disconnect the power amplifier module of transmitter 1 for

further investigation into the several issues found in transmitter 1.

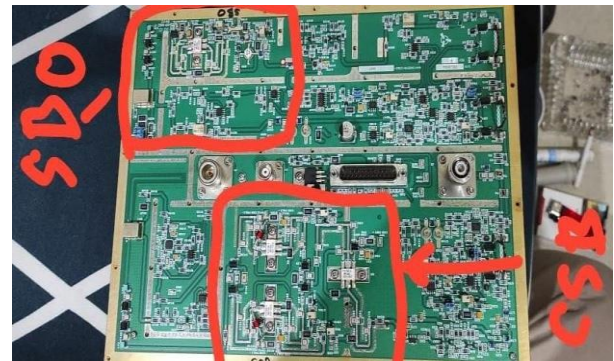
**Figure 5.** The Power Amplifier Module is in the Checking Process

The checking of the Power Amplifier module circuitry was conducted according to the schematic diagram provided by the manufacturer, Selex AMS Inc. However, an issue arose when it was discovered that the module was from the latest series, and Selex AMS Inc. did not produce a schematic diagram for the latest series. This was found after confirming with other branches that also use Selex AMS Inc. flight navigation equipment. Consequently, the technicians analyzed the Power Amplifier module because the schematic diagram and block diagram of Selex AMS Inc. navigation equipment showed that the Power Amplifiers between PA Course and PA Clearance had the same schematic diagram and produced the same signal output. The difference between PA Course and PA Clearance lied in their SBO signal output. PA Course produced CSB and SBO signals, both of which were used and routed to the transfer/recombiner unit block, whereas for PA Clearance, the SBO signal output was attenuated using a dummy load because the clearance signal in Glideslope only required a CSB 150 Hz signal in the lower sector of the

Problem Solutions states that it is imperative to confirm that all equipment is off and that no AC or DC current is flowing before unplugging the power amplifier module on the Glideslope equipment rack. It is done according to the method while disconnecting the power amplifier module. The next step is to remove the power amplifier and open the component covers to examine the electronic circuitry.

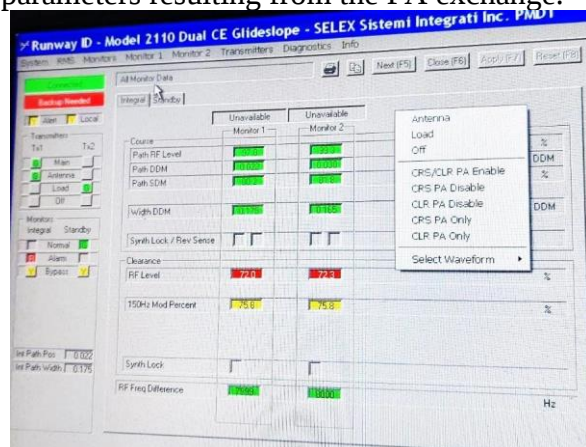
**Figure 7.** Parameter Reading on PMDT After Power Amplifier Module change

The results of the PMDT reading after the PA exchange indicated an integral transmitter alarm and the RF Level Clearance reading also showed an alarm indicator. The technicians then followed up on these alarms by adjusting the parameters on the PMDT. The parameter setting was followed by a ground check to assess the transmission results directly.

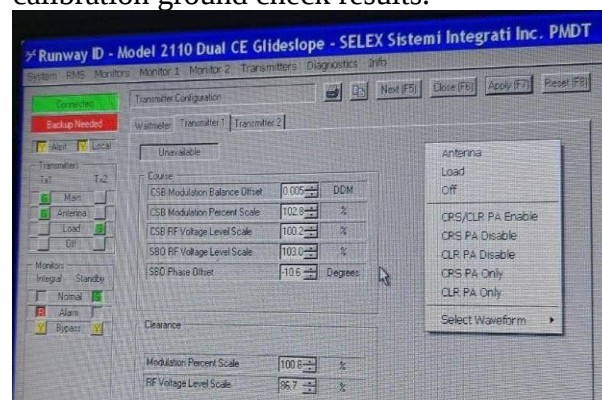
**Figure 9.** Parameter Setting On PMDT

After adjusting and aligning the parameters with the ground check parameters, the transmission results matched the post-calibration ground check results.

Then, the ground check results of the PA after the PA module swap were compared with the ground check results after calibration. This comparison was conducted by the technicians to analyze the glideslope transmission, ensuring that the transmission after the PA swap matched the ground check results post-calibration. This is because the post-calibration transmission results had confirmed that the Glideslope equipment was operating according to the parameter values, and the equipment was calibrated and working optimally. To match the calibration results, parameter settings on the PMDT were adjusted accordingly to achieve a transmission that aligns with the post-calibration ground check results.

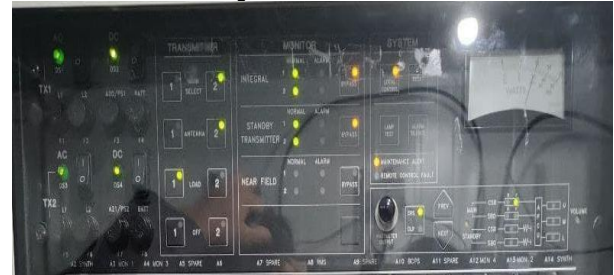
**Figure 13.** LCU Monitor Of Glideslope

The Local Control Unit (LCU) situation is depicted in Figure 13, where the green light indicates normal transmission characteristics following the power amplifier exchange.

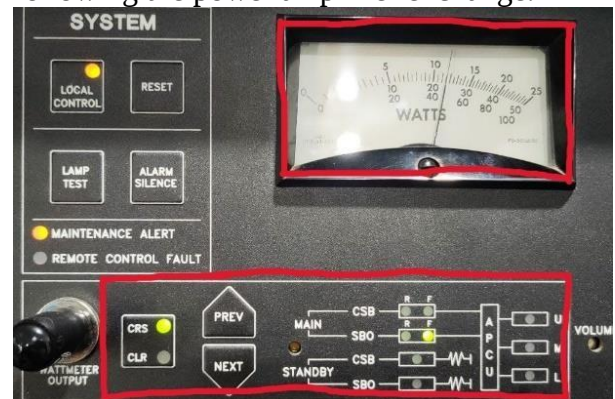
**Figure 14.** Wattmeter Power SBO Forward Reading Normal

The parameter readings returned to normal on the PMDT, followed by the normal condition of the LCU Monitor on the integral transmitter, along with stable readings of SBO power. Subsequently, the technicians experimented to determine the Glideslope transmission results after swapping the PA and adjusting parameters for an aircraft undergoing landing procedures using the ILS navigation facility.

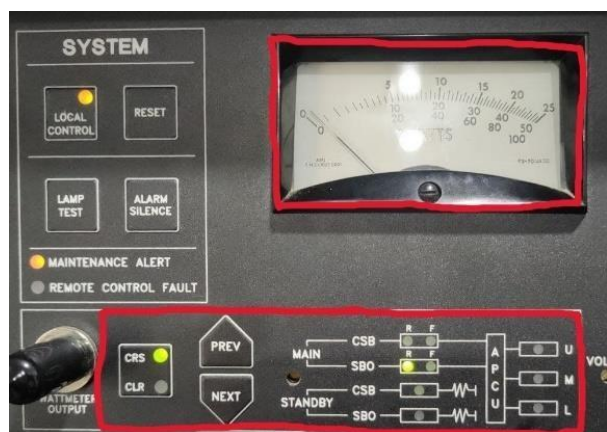
**Figure 15.** Wattmeter Power SBO Reflected

Figure 15 explains the reading of normal reflected SBO power.
