MAINTENANCE ACTION ON COURSE POWER AMPLIFIER TRANSMITTER GLIDESLOPE SELEX 2110

Abstract

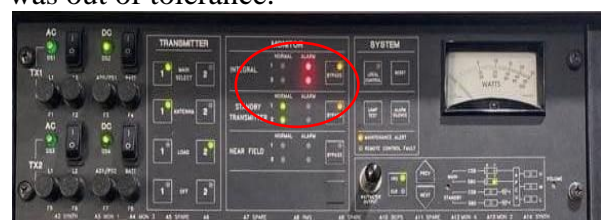
Figure 2. Alarm Condition on Monitor LCU

This research was conducted considering that glideslope equipment is crucial in the aircraft landing process, which impacts Runway Occupancy Time, as indicated by the study (Lim et al., 2020). Problem Analysis identify on December 27, 2022, there was a report from Approach Control Pekanbaru and Tower Pekanbaru that the glideslope signal for the aircraft was out of tolerance by 3°. Following up on this report, an analysis was conducted by directly inspecting the glideslope equipment shelter. It was found that the LCU monitor on the integral transmitter (transmitter

1) showed a Glideslope alarm, and the RF SBO Power reading on the Wattmeter was 0 watts. An inspection was also carried out using PMDT, and the reading for the width DDM was out of tolerance.

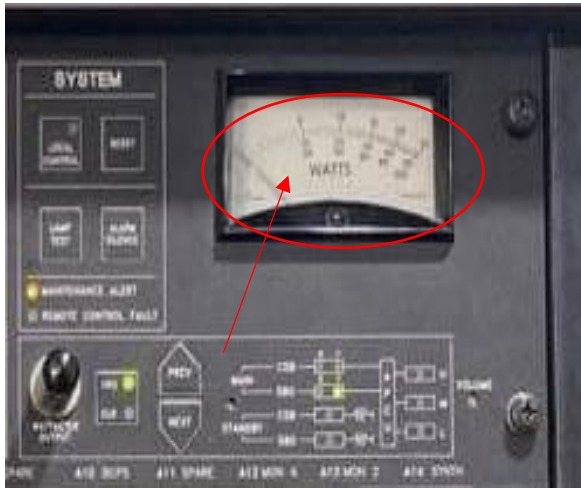
Figure 3. Reading of the Wattmeter on the SBO Power Parameter

The action of checking the equipment monitor and reading the power parameter on the Glideslope equipment is carried out to determine the cause of the aircraft receiving a Glideslope signal that is too high (Ariba et al., 2017). Subsequently, further checking of the transmission parameters using PMDT is conducted.

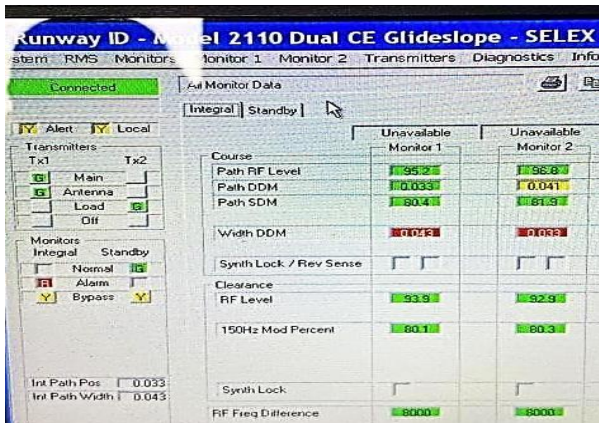
Figure 4. Reading of the Transmission Parameters on the PMDT

Checking the transmission using PMDT on all monitor data of the integral transmitter yielded parameter readings indicating that the width DDM was below the normal limit, triggering an alarm. Several findings were noted alarm on the LCU Integral transmitter monitor, parameter reading of RF Power SBO at 0 Watt parameter reading of the integral transmitter's transmission on PMDT showed Width DDM below the normal limit. The subsequent action taken is to disconnect the power amplifier module of transmitter 1 for

further investigation into the several issues found in transmitter 1.

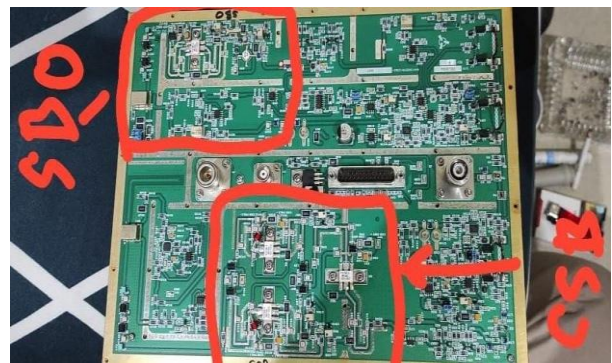
Figure 5. The Power Amplifier Module is in the Checking Process

The checking of the Power Amplifier module circuitry was conducted according to the schematic diagram provided by the manufacturer, Selex AMS Inc. However, an issue arose when it was discovered that the module was from the latest series, and Selex AMS Inc. did not produce a schematic diagram for the latest series. This was found after confirming with other branches that also use Selex AMS Inc. flight navigation equipment. Consequently, the technicians analyzed the Power Amplifier module because the schematic diagram and block diagram of Selex AMS Inc. navigation equipment showed that the Power Amplifiers between PA Course and PA Clearance had the same schematic diagram and produced the same signal output. The difference between PA Course and PA Clearance lied in their SBO signal output. PA Course produced CSB and SBO signals, both of which were used and routed to the transfer/recombiner unit block, whereas for PA Clearance, the SBO signal output was attenuated using a dummy load because the clearance signal in Glideslope only required a CSB 150 Hz signal in the lower sector of the

Problem Solutions states that it is imperative to confirm that all equipment is off and that no AC or DC current is flowing before unplugging the power amplifier module on the Glideslope equipment rack. It is done according to the method while disconnecting the power amplifier module. The next step is to remove the power amplifier and open the component covers to examine the electronic circuitry.

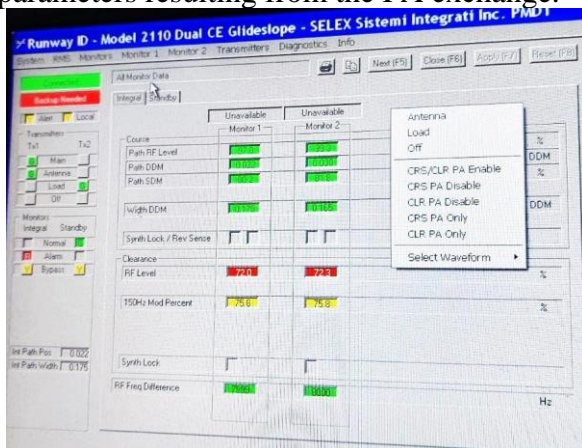
Figure 7. Parameter Reading on PMDT After Power Amplifier Module change

The results of the PMDT reading after the PA exchange indicated an integral transmitter alarm and the RF Level Clearance reading also showed an alarm indicator. The technicians then followed up on these alarms by adjusting the parameters on the PMDT. The parameter setting was followed by a ground check to assess the transmission results directly.

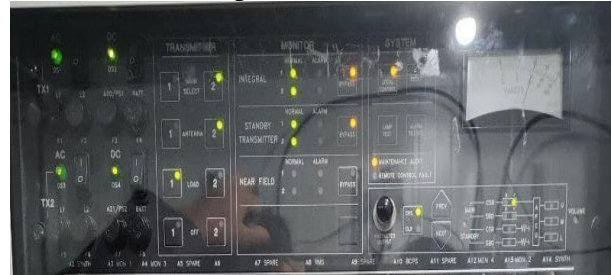
Figure 13. LCU Monitor Of Glideslope

The Local Control Unit (LCU) situation is depicted in Figure 13, where the green light indicates normal transmission characteristics following the power amplifier exchange.

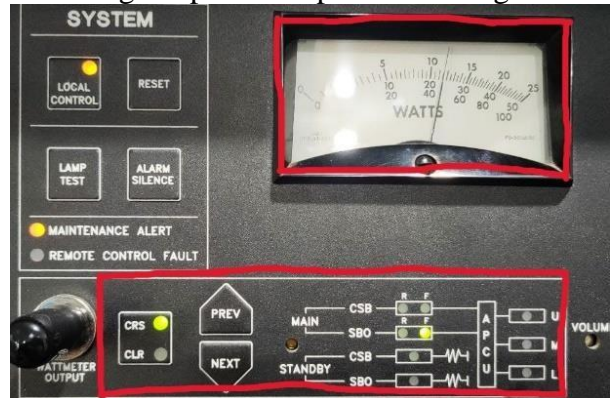
Figure 14. Wattmeter Power SBO Forward Reading Normal

The parameter readings returned to normal on the PMDT, followed by the normal condition of the LCU Monitor on the integral transmitter, along with stable readings of SBO power. Subsequently, the technicians experimented to determine the Glideslope transmission results after swapping the PA and adjusting parameters for an aircraft undergoing landing procedures using the ILS navigation facility.

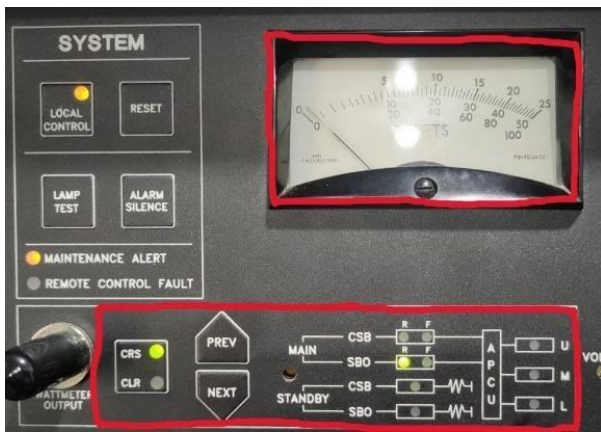
Figure 15. Wattmeter Power SBO Reflected

Figure 15 explains the reading of normal reflected SBO power.
