AN EMERGENCY RESPONSE: THE AVAILABILITY OF ACCESS ROAD AT THE INTERNATIONAL AIRPORT

Politeknik Penerbangan Palembang

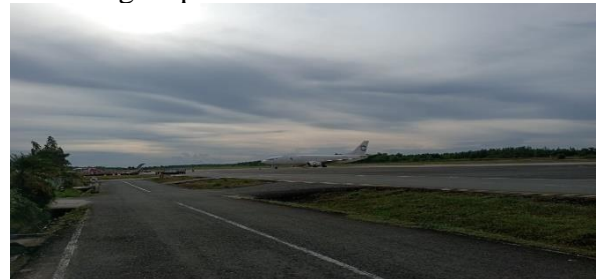
Figure 1. Aircraft Parking Stand

In Figure 1, there is an aircraft in the parking stand area. An aircraft parking stand is a certain place at the airport that is used for aircraft parking (Qin et al., 2018). This can be classified as an obstacle to the ARFF vehicle movement process. ARFF officers must divide their attention between watching aircraft movements and calculating response time to get to the source of the accident/incident.

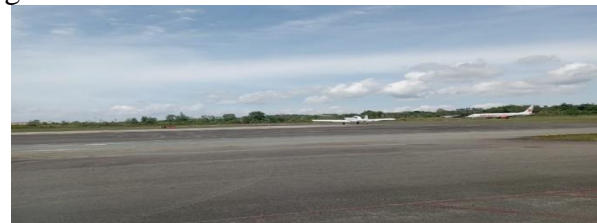
Figure 2. Aircraft Holding Position

Figure 2 shows the movement of aircraft while holding on the ground. The unavailability of access roads can hinder ARFF vehicles and ARFF officers during an accident or incident. The aircraft will hold first before entering the Runway and taking off. This aircraft holding is an air traffic control procedure to ensure safety and operational efficiency.

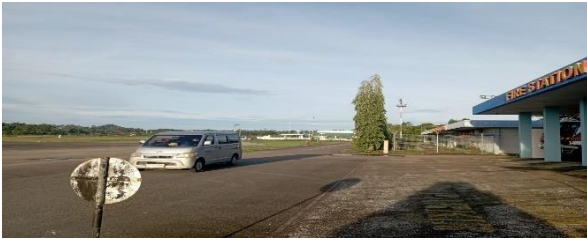
Figure 3. Ground Vehicle in Service Road

The movement of ground vehicles on the service road as seen in Figure 3 can cause interference with the movement of aircraft rescue and firefighting vehicles. Ground vehicles are all vehicles operating in the airport area, such as baggage towing tractor, aircraft towing tractor, ground power unit, pushback car, trucks and others (Shvetsov, 2022). All of these vehicles play an important role in maintaining smooth airport operations, optimising aircraft service times, and ensuring safety on the ground.

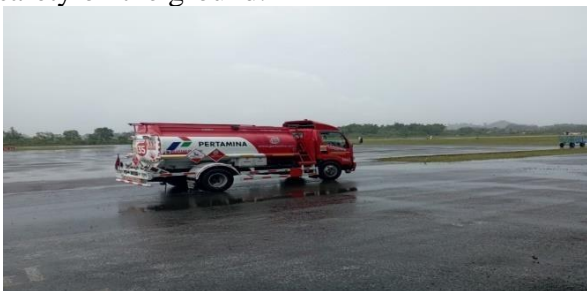
Figure 4. Pertamina Vehicle in Main Apron

Similarly, as shown in figure 4, Pertamina vehicles located on the main apron. These Pertamina vehicles transport and provide aviation fuel (Kadarwati, 2022), avtur, thus ensuring smooth and secure energy supply for aircraft at various airports. The vehicle can become obstacles for aircraft rescue and firefighting vehicles so that they impact the achievement of response time.

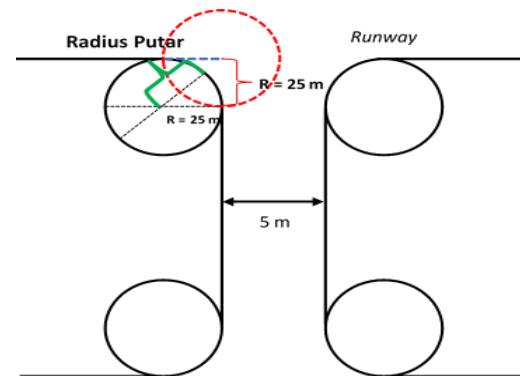
Figure 5. Required Access Road Structure

The access road must have a minimum width of five meters and a minimum turning radius of 25 metres at each meeting of the access road with the Fire Station or taxiway or Runway as shown in Figure 5. Obstacles will make ARFF operational vehicles do too many maneuvers to pass through several possible obstacles. This means that researchers can conclude that in the absence of Access road as stipulated in the Regulation of the Director General of Civil Aviation No. 30 the Year 2022, this research refers to the guidelines and requirements set by the regulation, ARFF Juwata Tarakan vehicles are not yet accessible from other access roads because they must pay attention to several obstacles, one of which is aircraft movement.
