AVIOBRIDGE MAINTENANCE MANAGEMENT: A SOLUTION FOR CABIN CURTAIN DAMAGE

Keywords: aviobridge, cabin curtain, maintenance, damage

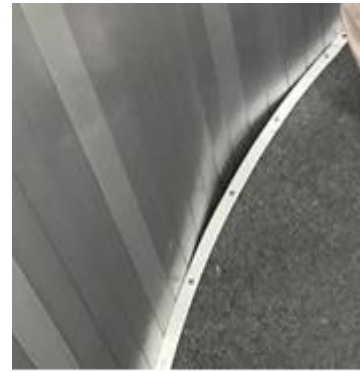
From the results of checking it can be concluded that the lack of maintenance was not carried out properly so that the curtain came out of the cabin path, indications of this problem include between the dry curtains, the curtain gear at the top of the cabin is loose and the top and bottom bolts on each side of the curtain are loose. This of course will have an impact on the cabin curtain work system and can also be dangerous for passengers. Influence and impact, if the curtain comes out of the cabin path, called passengers, may be trapped, unstable curtain movement rotation, and the sound of the curtain becomes harsh.

Figure 1. The curtain is out of the way of the cabin

How to handle so that the curtain does not come out of the cabin path is lubrication on the sidelines of the curtain using lubricant simultaneously with the movement of the cabin rotation to the right and left and check the roller curtain at the top and bottom. How to prevent the curtain from getting out of the way of the cabin is to perform routine daily checks of the right and left curtains. Following are the steps for routine daily curtain checks to carry out lubrication on the curtain's sidelines using lubricant and lubricating the curtain chain outside the cabin.

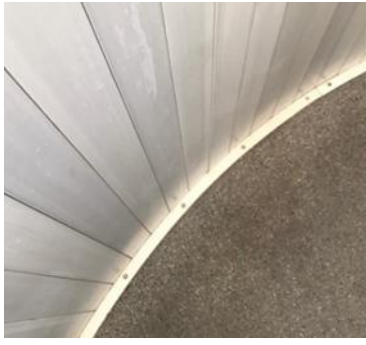
Figure 2. Curtain condition after maintenance

Maintenance on the curtain of the aviobridge, is carried out daily, weekly, and monthly. Curtain daily maintenance done by the sidelines of the curtains must be lubricated using lubricant, simultaneously with the movement of the cabin curtain to the right or left so that the gaps between the curtains do not dry out and the rotation of the cabin becomes stable. Curtain maintenance is checked once every week and month by pressing the curtain from the inside. Curtains that are to things or things will be sunken outward. If the voltage does not match the curtain from the curtain barrel panel winding it will be carried out.

First, remove the curtain barrel cabin cover from the top of the cabin leading to the curtain reel. For the cabin open the lid or cover the curtain barrel which is hinged so that the coil can be seen. After that, position the cabin to the right or left so that the curtain to be adjusted can be fully opened. Rotate the cabin slowly so that the open curtain starts to roll. Turn the aviobridge in the direction that the curtain will fail to roll without manual assistance. Without holding or pressing on the curtain, turn the worm gear counterclockwise for the left curtain and clockwise for the right curtain, until the curtain is pulled tight against the bobbin. Continue this procedure until the curtain rotates from the open position without any problems. Rotate the aviobridge in both directions to check if the curtain has the proper tension.
