AVIOBRIDGE MAINTENANCE MANAGEMENT: A SOLUTION FOR CABIN CURTAIN DAMAGE

Ingelda Gabrella¹, Imam Hariadi Wibowo², Annisa Baby Callista³

¹Politeknik Penerbangan Palembang, ²Politeknik Penerbangan Indonesia Curug

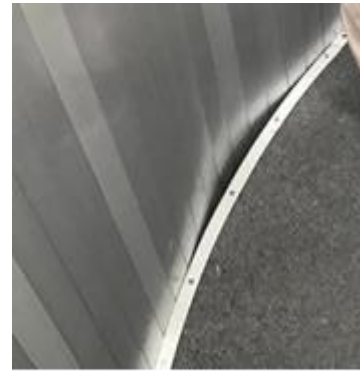
The problem indication is during a pandemic, PT. Angkasa Pura I (Persero) especially at Jenderal Ahmad Yani Semarang International Airport, decided to minimize technicians to streamline the budget. This decision affected all technicians in the aviobridge unit. So that no maintenance was carried out but the aviobridge unit on the cabin curtain section of the aviobridge N06 has trouble, namely the curtain is coming out of the cabin lane.

From the results of checking it can be concluded that the lack of maintenance was not carried out properly so that the curtain came out of the cabin path, indications of this problem include between the dry curtains, the curtain gear at the top of the cabin is loose and the top and bottom bolts on each side of the curtain are loose. This of course will have an impact on the cabin curtain work system and can also be dangerous for passengers. Influence and impact, if the curtain comes out of the cabin path, called passengers, may be trapped, unstable curtain movement rotation, and the sound of the curtain becomes harsh.

Figure 1. The curtain is out of the way of the cabin

How to handle so that the curtain does not come out of the cabin path is lubrication on the sidelines of the curtain using lubricant simultaneously with the movement of the cabin rotation to the right and left and check the roller curtain at the top and bottom. How to prevent the curtain from getting out of the way of the cabin is to perform routine daily checks of the right and left curtains. Following are the steps for routine daily curtain checks to carry out lubrication on the curtain's sidelines using lubricant and lubricating the curtain chain outside the cabin.

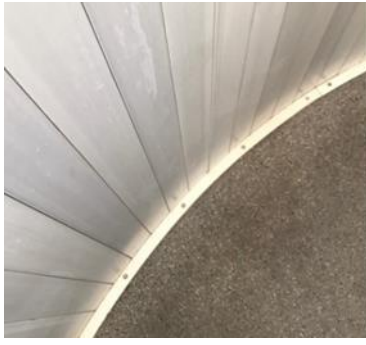
Figure 2. Curtain condition after maintenance

Maintenance on the curtain of the aviobridge, is carried out daily, weekly, and monthly. Curtain daily maintenance done by the sidelines of the curtains must be lubricated using lubricant, simultaneously with the movement of the cabin curtain to the right or left so that the gaps between the curtains do not dry out and the rotation of the cabin becomes stable. Curtain maintenance is checked once every week and month by pressing the curtain from the inside. Curtains that are to things or things will be sunken outward. If the voltage does not match the curtain from the curtain barrel panel winding it will be carried out.

First, remove the curtain barrel cabin cover from the top of the cabin leading to the curtain reel. For the cabin open the lid or cover the curtain barrel which is hinged so that the coil can be seen. After that, position the cabin to the right or left so that the curtain to be adjusted can be fully opened. Rotate the cabin slowly so that the open curtain starts to roll. Turn the aviobridge in the direction that the curtain will fail to roll without manual assistance. Without holding or pressing on the curtain, turn the worm gear counterclockwise for the left curtain and clockwise for the right curtain, until the curtain is pulled tight against the bobbin. Continue this procedure until the curtain rotates from the open position without any problems. Rotate the aviobridge in both directions to check if the curtain has the proper tension.
